Manhole Inspection Summary

Manhole # S23E1_011MH

Insp Date: **7/22/08 11:46 AM**

Location Address: **2501 Waterview Av**

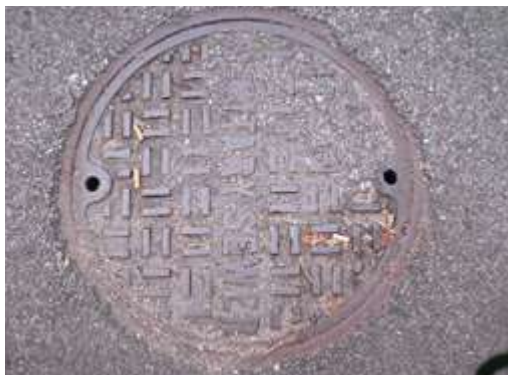
Miscellaneous

MH Cover

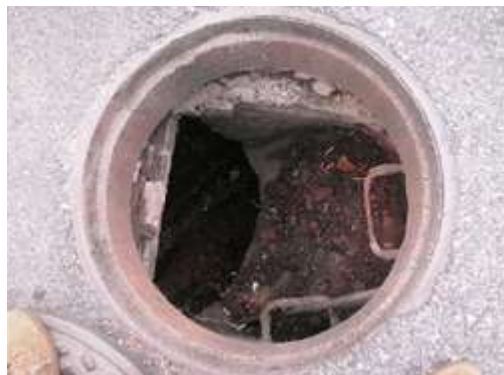
Defect 1

Frame Offset: **3** (in.) Condition: ☒ Sound ☐ Cracked ☐ Leaks

offset top & chimney

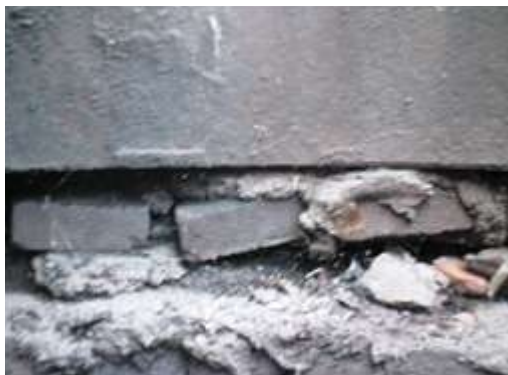
Defect 3

Condition: ☐ Sound ☐ Cracked ☐ Root Intrusion ☐ Loose Brick ☒ **Deteriorated**

chimney deteriorated

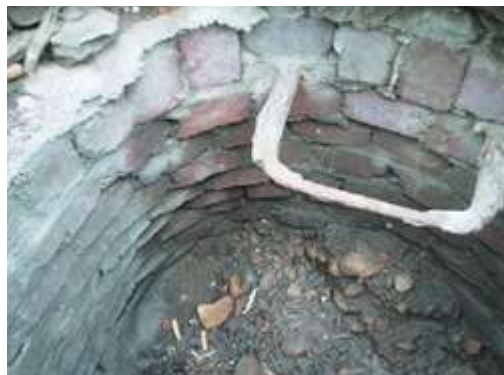
Defect 4

Infiltration: ☐ None ☒ **Joint** ☐ Cracks ☒ **Mortar** ☐ Roots ☒ **Wall**

Condition: ☐ Sound ☐ Cracked ☐ Root Intrusion ☐ Deteriorated ☐ Leaks ☒ **Debris**

Steps Count: **3** Missing: **0** ☒ **Corroded**

signs of infiltration at chimney mortar, joint, & wall, bench debris, corroded steps

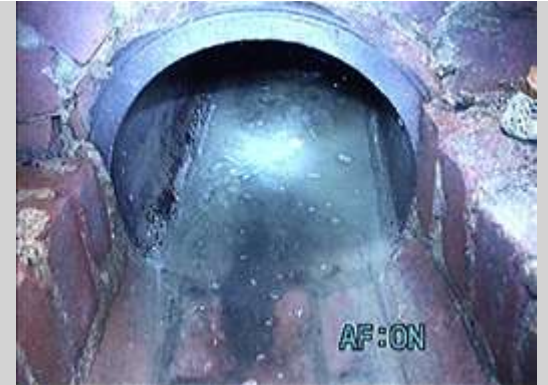
12 O'Clock Outflow

10 in. Circular Gravity Sewer
Pipe Out @ 12 O'Clock

Pipe Height: **10.8** (in.) Rod and Bar (Angled)
Pipe Material: **Clay** ☐ Pipe Lined
Invert Depth: **6.99** (ft.) Flow Characteristics: **Slow**
Deposits: ☒ None ☐ Mud ☐ Sludge ☐ Debris ☐ Grease
Silt Depth: **0** (in.) Deposits Extent:
Infiltration: **None** Pipe Seal Cond: **Sound**

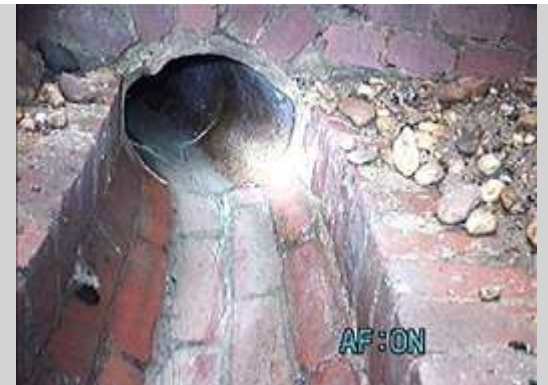
5 O'Clock Inflow

8 in. Circular Gravity Sewer
Pipe In @ 5 O'Clock

Pipe Height: **8.4** (in.) Rod and Bar (Angled)
Pipe Material: **Clay** ☐ Pipe Lined
Invert Depth: **7.04** (ft.) Flow Characteristics: **Slow**
Deposits: ☒ None ☐ Mud ☐ Sludge ☐ Debris ☐ Grease
Silt Depth: **0** (in.) Deposits Extent:
Infiltration: **None** Pipe Seal Cond: **Sound**
